Crow's Nest Home Inspections, LLC
1910 4th AVE E #149
Olympia, WA 98506
(206) 310-2613

Report #: SampleReport

1234 156th Lane NE
Sunny, WA 98000

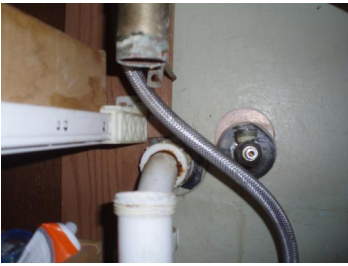
73-1. Sink

Missing waste pipe underneath the bathroom sink

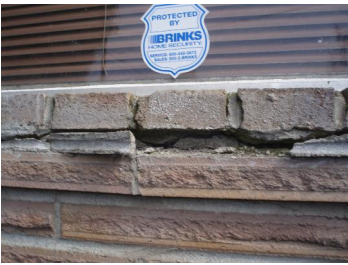
09-1. Exterior Walls

Comments: MAJOR DEFERRED MAINTENANCE: The paint is peeling, weathered and aged in numerous locations, most evident on the South and West sides of the house. Recommend a licensed and bonded painting contractor properly prepare the exterior surfaces and paint the house. The front of the house has a brick facade on the lower portion of the siding. The mortar in the brick is deteriorated, loose and missing on the first row of bricks. Numerous bricks are loose. Recommend a licensed and bonded brick mason tuckpoint the brick facade as needed.

Deteriorated brick mortar and loose bricks in the front brick facade

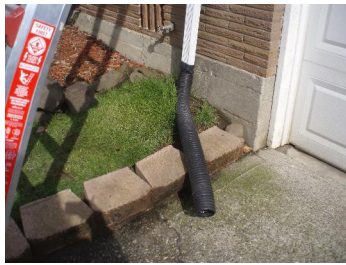
14-1. Gutters & Downspout

Downspout diverts water into driveway and garage

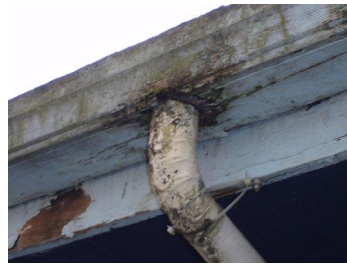
14-2. Gutters & Downspout

Comments: MINOR REPAIRS: The gutter and downspout system on the North side of the house appears to be the original wood gutter and galvanized metal gutter system. The system appears beyond the expected lifespan. The gutters are wood rotted and the downspout is disconnected from the gutter and leaks. The downspouts divert roof water run off next to the garage entrance, creating a condition for potential moisture intrusion into the garage and moisture damage, see pictures. Recommend a licensed and bonded gutter contractor replace the original wood gutter and galvanized metal downspout on the North side of the house. route the downspouts at least six feet away from the foundation of the house. DISCLAIMER: The downspouts divert roof water run off into a subsurface drain system. Subsurface drain systems are beyond the scope of a home inspection and are excluded from the report.

Original wooden gutters rotted on North side

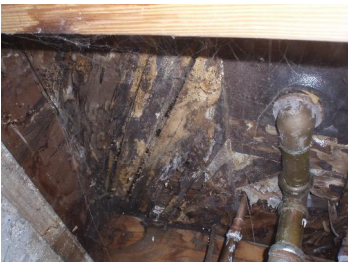
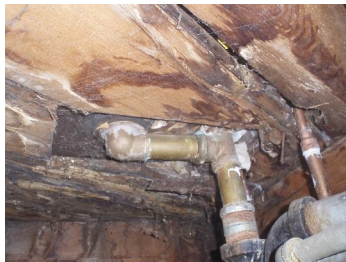
17ba-1. Floor Structure

Comments: MAJOR REPAIRS/ADDITIONAL INSPECTIONS: The inspector observed severe moisture damage to the subfloor underneath the bathtub, see pictures. The area encompasses an approximately 3x4 foot area. Also, see notes about shower enclosure in the Bathroom section. Recommend a licensed and bonded contractor further inspect the inside of the shower enclosure for further moisture damage to the wall framing and make all repairs deemed necessary.

Severe wood rot underneath the bathtub in the crawlspace

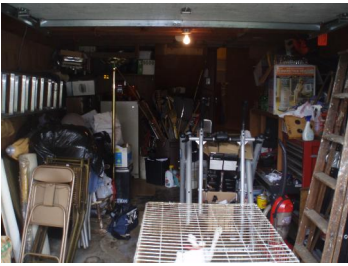
65a-1. Comments

The occupant's possessions limit the view of the garage inspection

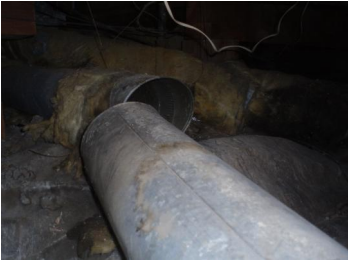
33-1. Distribution

Disconnected ductwork in the crawlspace, ductwork missing insulation

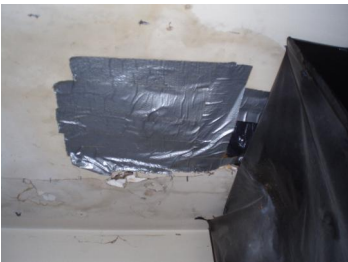
50-1. Ceilings

Moisture damage and temporary repair to ceiling in NW bedroom

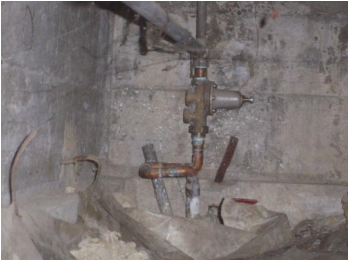
23-1. Main Line

The main line is copper with a water pressure regulator installed
